Bone Lake

Shoreline Inventory Report, 2025

Prepared by
Colton Sorensen & Katelin Anderson
Polk County Land and Water Resources Department
100 Polk County Plaza, Suite 120, Balsam Lake, WI 54810

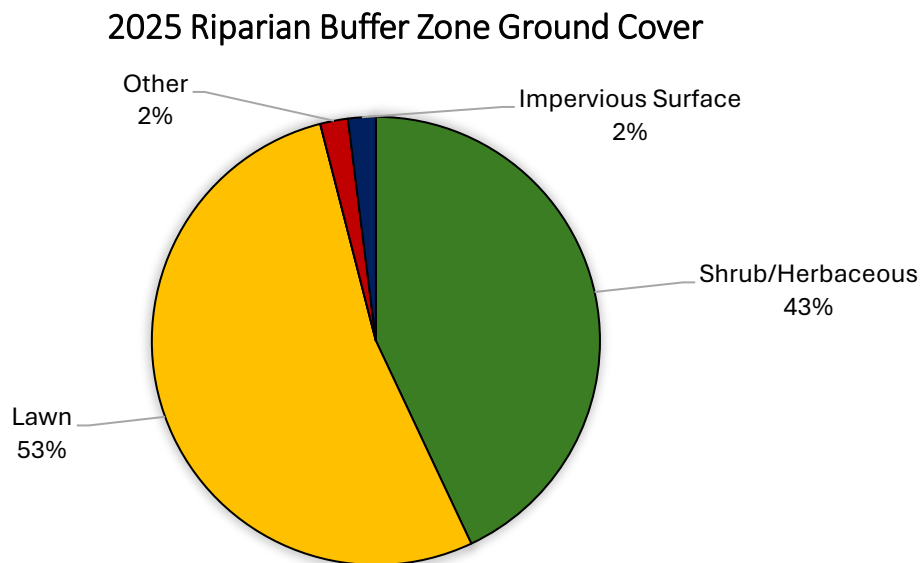
When considering the entire riparian buffer zone, the predominant ground cover on Bone Lake was lawn (53%), followed by shrub/herbaceous (43%). Two percent of the ground cover in the

riparian buffer zone was impervious surface and two percent was other ground covers (bare soil, landscaping, rock, dead grass, and artificial beach).

Percent ground cover for shrub/herbaceous, impervious surface, and manicured lawn were determined for the riparian buffer zone of each parcel. The average ground cover in the riparian buffer zone per parcel was 69% lawn, 26% shrub/herbaceous, 3% other, and 2% impervious.

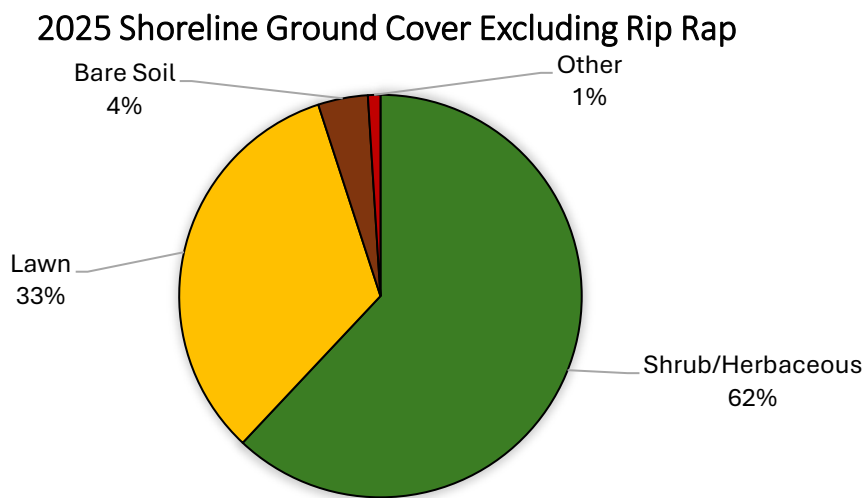
The 2025 shoreline inventory found that 62% (47,436 feet) of the shoreline touching the water's edge on Bone Lake was shrub/herbaceous, 33% (25,072 feet) was manicured lawn, and 4% was bare soil (2,738 feet). Impervious surfaces, landscaping, sand deposits, and other landcovers made up the remaining 1% (709 feet). These calculations do not consider rip rap as a ground cover at the water's edge.

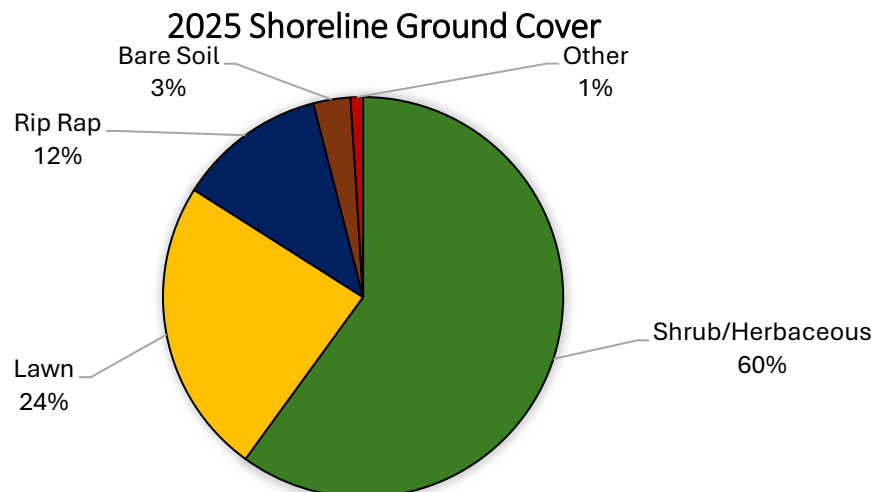
To make the two surveys comparable, rip rap was also calculated as a ground cover at the water's edge. This analysis found that 60% (45,951 feet) of the shoreline touching the water's edge on Bone Lake was shrub herbaceous, 24% (17,874 feet) was manicured lawn, 12% (9,236 feet) was rip rap, 3% (2,264 feet) was bare soil, and the remaining 1% was other land covers.

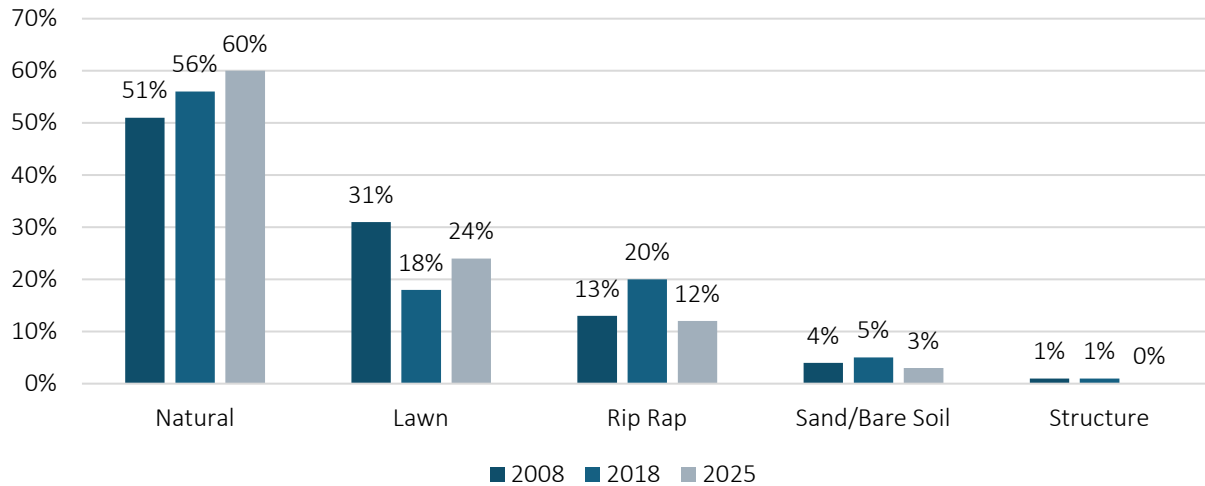
Shoreline Edge

In all three surveys (2008, 2018, and 2025), natural vegetation was the predominant ground cover at the water's edge, with the amount of natural vegetation increasing each year since 2008. When comparing 2008 to 2025 the amount of lawn has decreased over time and the amount of rip rap has mostly stayed consistent. However, in 2018 the amount of lawn was less than in 2008 and 2025 and the amount of rip rap was more than in 2008 and 2025. The amount of sand/bare soil and structure/impervious surface has stayed consistent across all three surveys.

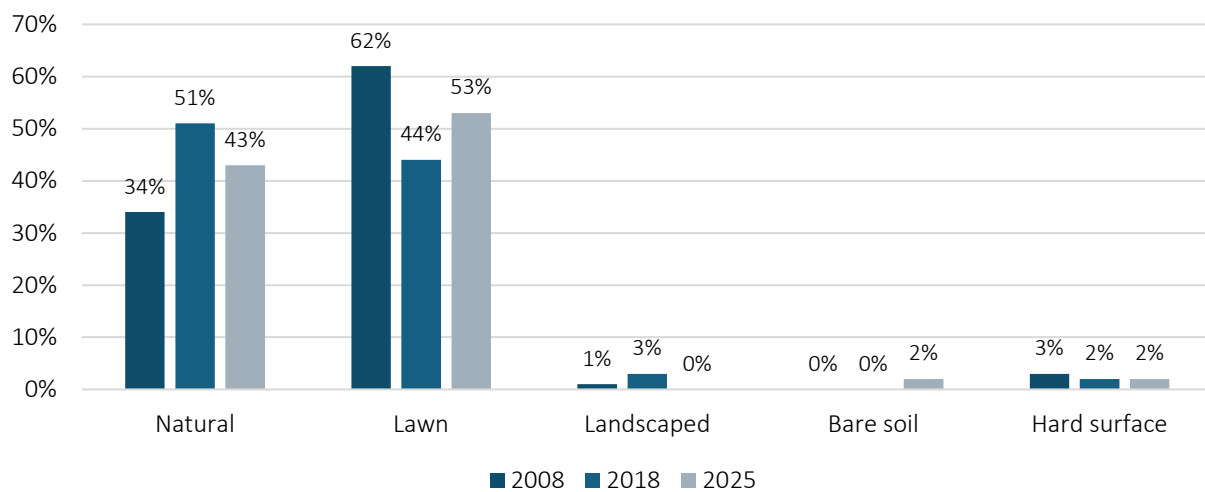
Riparian Buffer Zone

The amount of natural ground cover in the riparian buffer zone increased from 2008 to 2018, and decreased from 2018 to 2025. Conversely, the amount of lawn in the riparian buffer zone decreased from 2008 to 2018 and increased from 2018 to 2025. The amount of landscaping, sand/bare soil, and structure/impervious surface has stayed consistent across all three surveys.
